X-ray inspection of Rubber hoses (with different defects)

Defects: burns on surface, hole in side wall of hose, salt inside hose, particle inside of hose, spots on surface.

Samples were inspected batch by batch. Inspected using low energy X-rays.

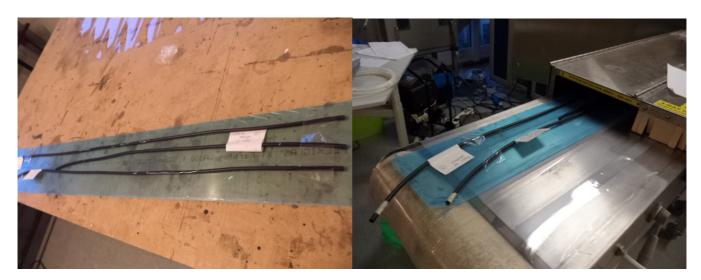
Rubber Hoses Burnt and w/ salt inside, Image 1

Abundant salt deposits internally to upper hose. The hose in the middle is thinner in wall thickness

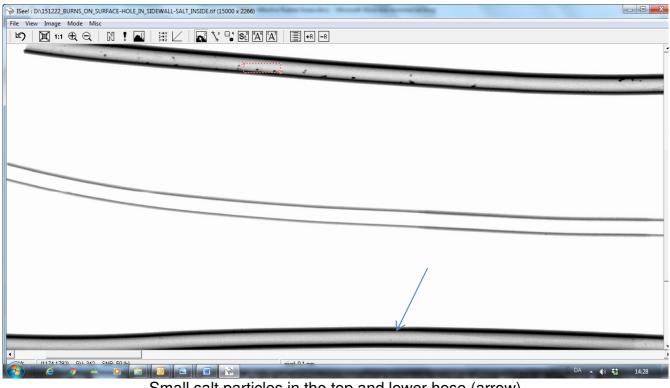
Holes in the wall of the upper and middle hose

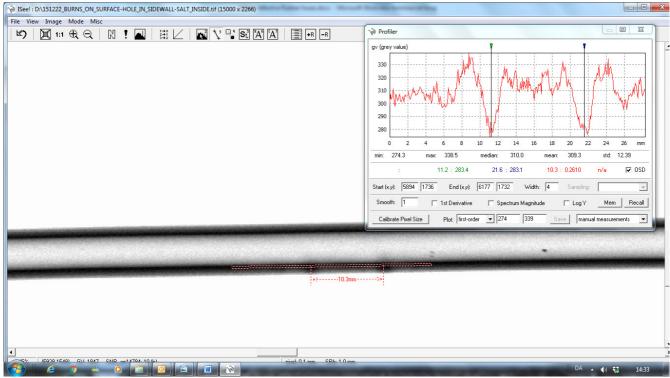
Small salt particles in the top and lower hose (arrow)

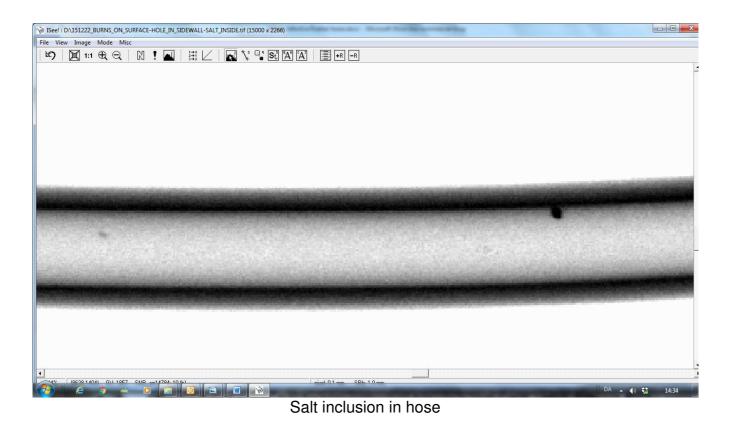
Dark areas in the wall of the lower hose. Profile line shows irregularities (dips) in the grey level profile (which should be fairly even for an undamaged hose wall)

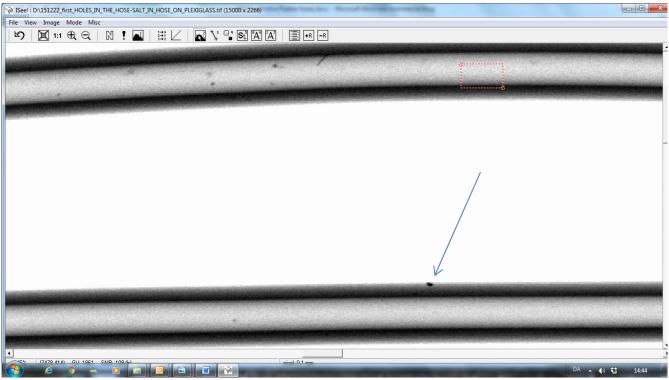
Holes and abundant salt particles in several hoses - left part of image

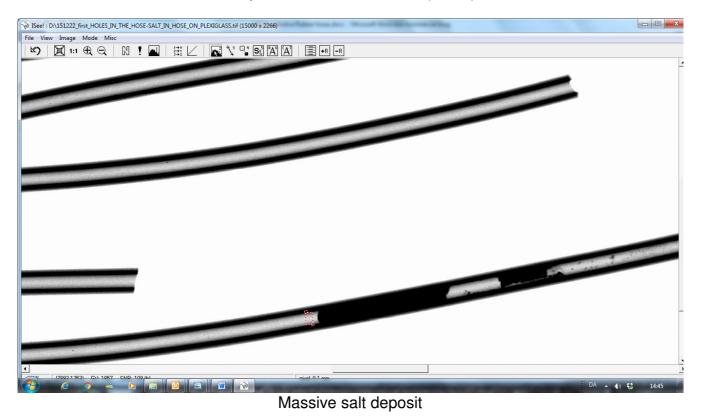
Example of hose with many very small and scattered salt particles, also seen (lower hose) is salt particle on outer surface (arrow).

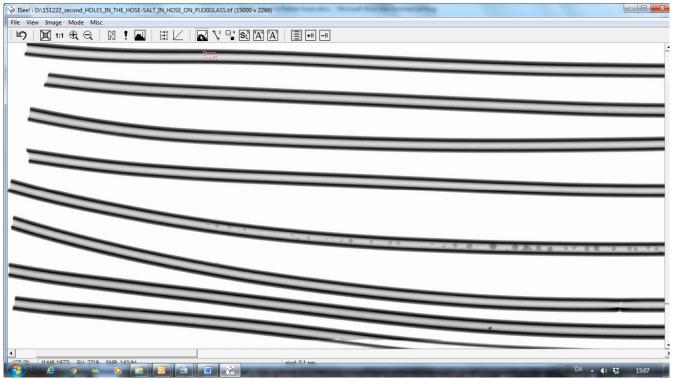
Leftmost part – prominent salt in middle lower hose

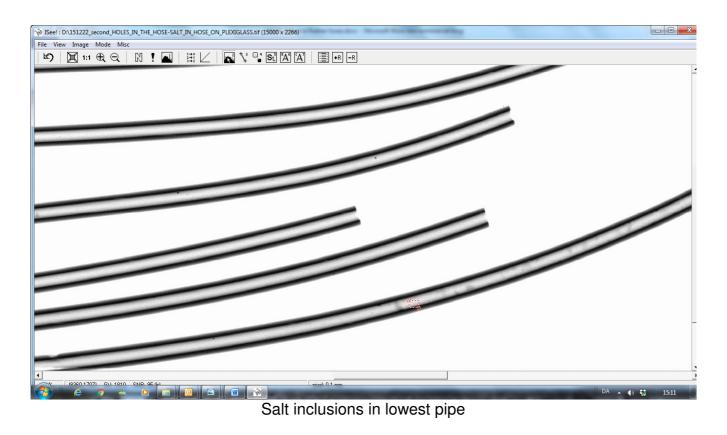
Hole in the lowest pipe (arrow)

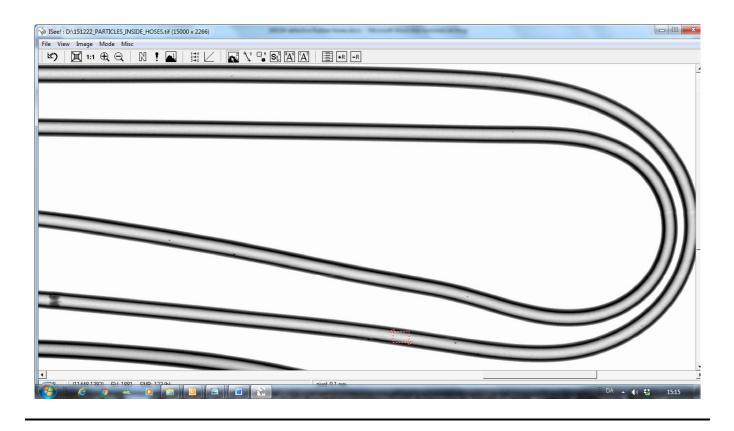
Particles and blockage of hose

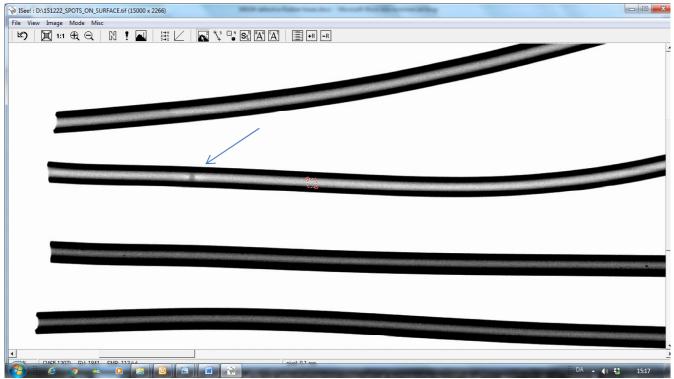
Reduced wall thickness

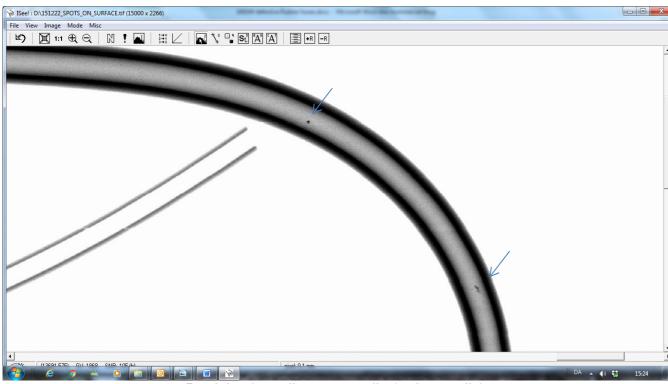
External dents and deposits and a "blow hole"

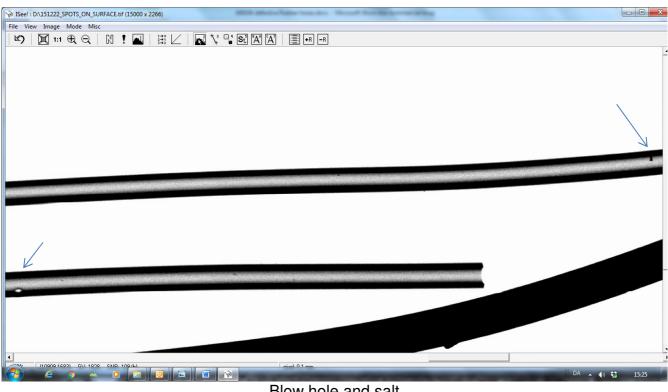
Particles in wall or externally (or internally)
