X-ray Imaging of External Corrosion on Insulated Steel Pipes

To present the technical solution regarding tangential imaging of insulated pipes using low energy X-ray real-time imaging.

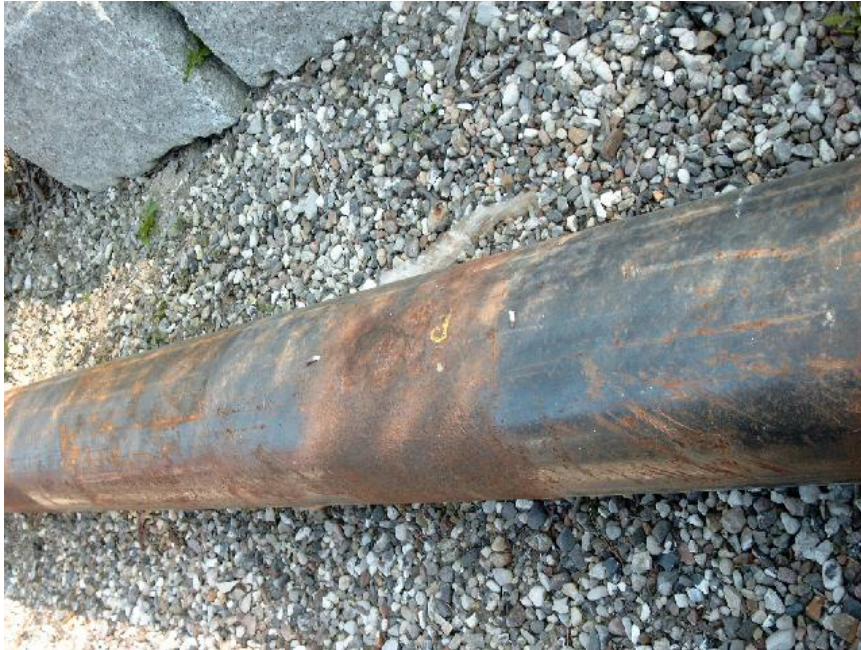
Fig. 2. Corroded 6" test pipe. Corrosion pitting is up to 5-6 mm. Insulation removed to portray the corrosion pitting. Pitting is left to the "P" mark (upside down) in the middle.
