Automatic detection and rejection of avocado fruits with internal damage caused by ripeness and of seeds with poor sprout capability

Low-Energy, High Contrast, High Resolution X-ray Technology

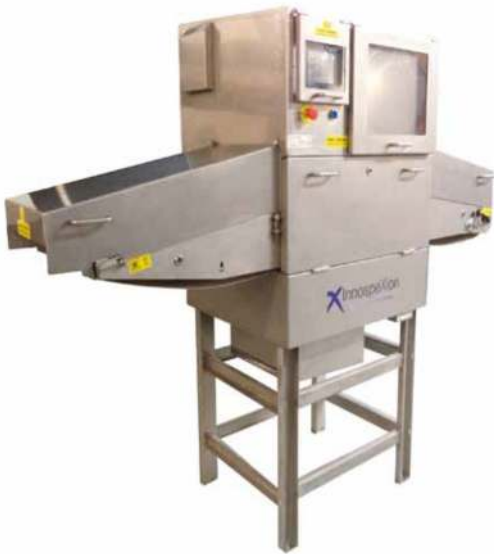
Fig. 1. HYMCIS low-energy X-ray system

The InnospeXion food inspection system is based on the **newest and most effective X-ray technology**, providing high contrast and high resolution X-ray images.

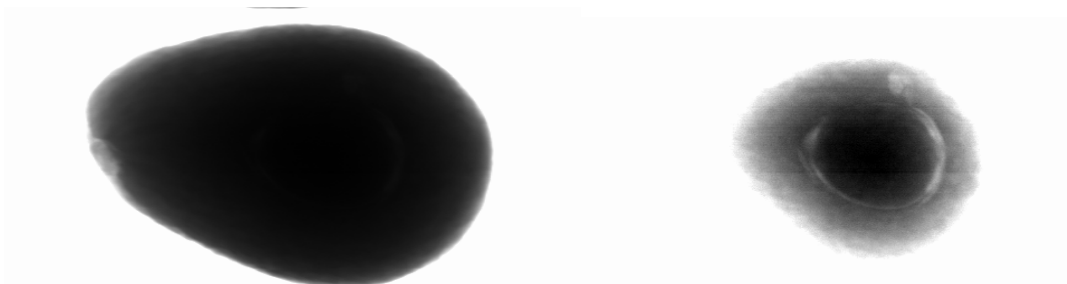
Fig. 9 and 10. Low energy X-ray image of a "just at the ripe point" avocado. In the image at the right, the grey level range of the picture at the left has been adjusted to allow a study of the region near the central kernel. It can be seen, that the just ripe avocado has developed a small void between the central kernel and the surrounding fruit (see section image Fig. 11).

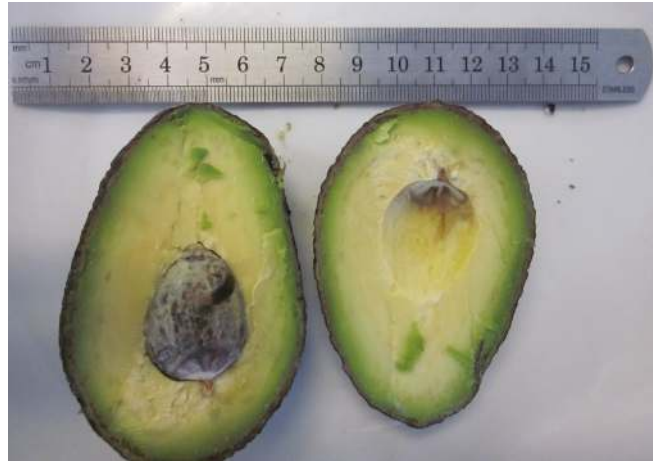
Fig. 11. At the ripe point avocado from Figs. 9 and 10.
