Blister samples

This note presents selected X-ray images of blister packages acquired using the InnospeXion low energy X-ray technology. The samples considered are taken off a production, in some cases due to non-conformity of the blister packaging.

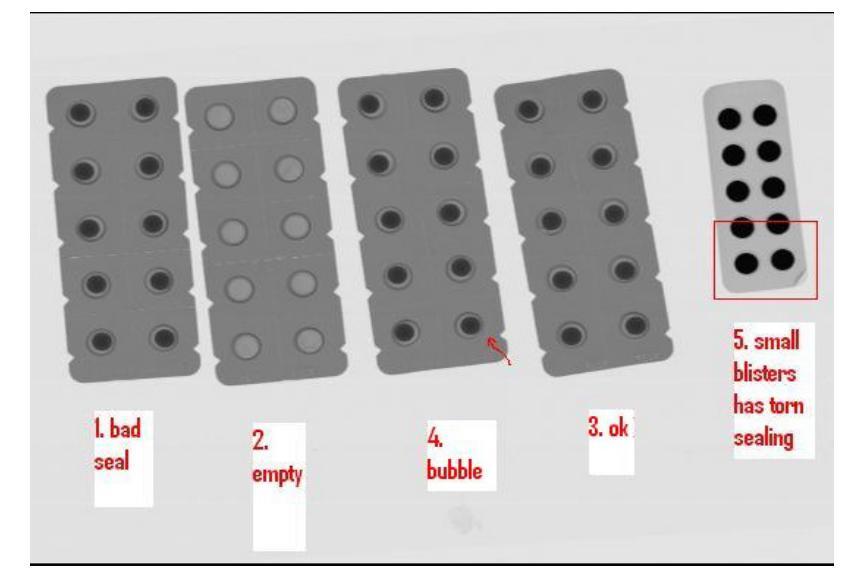
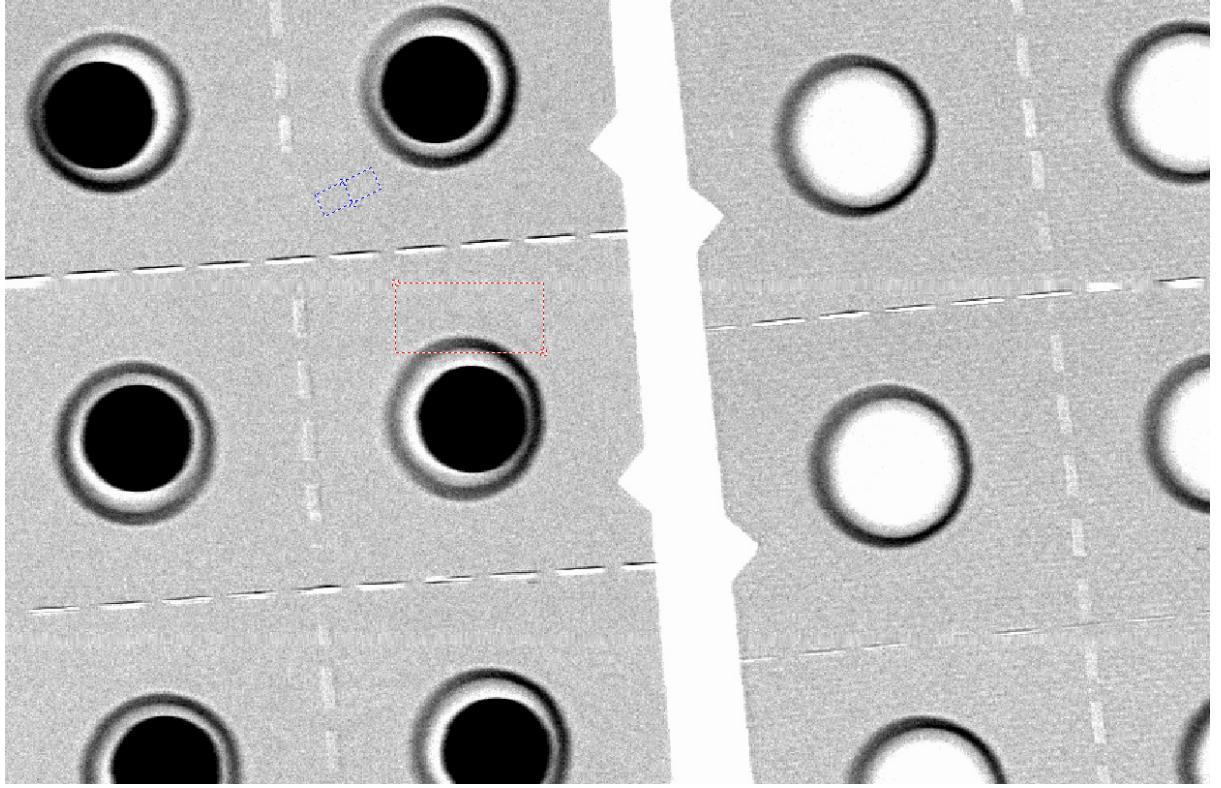
Blister 1) The image shows the blister with bad sealing to the left and the empty blister to the right. It is possible to see differences in the blister "cup", because the small circles forming the cups are irregular and of lower attenuatuion in some of the blister cups to the left cp. To the same cups at the empty blister to the right.

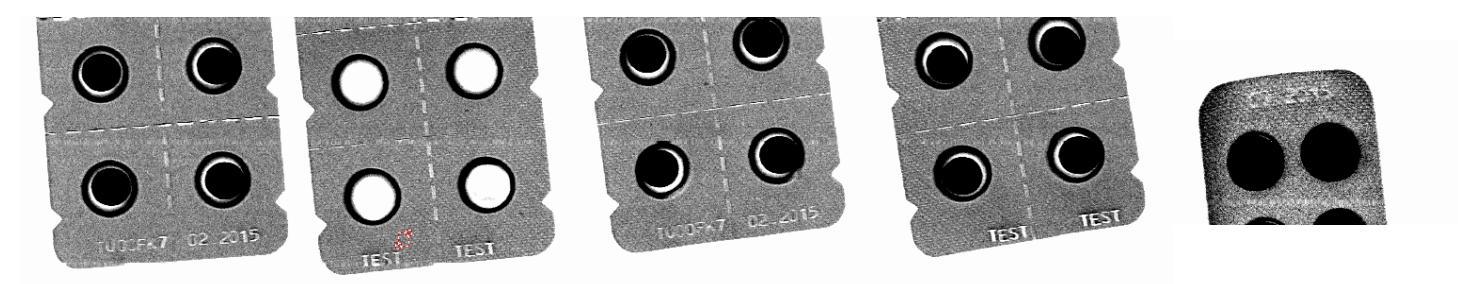
The X-rays can also detect the batch numbers and date. The images below show that part of the text is legible, although not all of the batch number is clear.

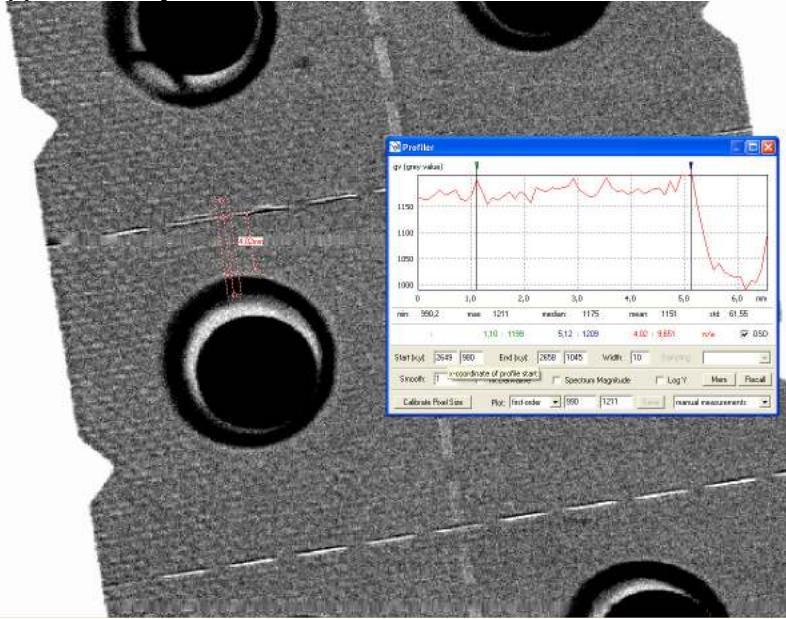
The dimensions from the tablet bubble edge to the edge and perforation has to be at least 2-3 mm. The X-ray image below shows one of the samples which were closest to the perforation with approximately 4 mm.
